PENNSYLVANIA  
**PENN LAKE DAM**

NDI-PA 00542  
PA DER 40-28

PHASE I INSPECTION REPORT  
NATIONAL DAM INSPECTION PROGRAM

MARCH 1979

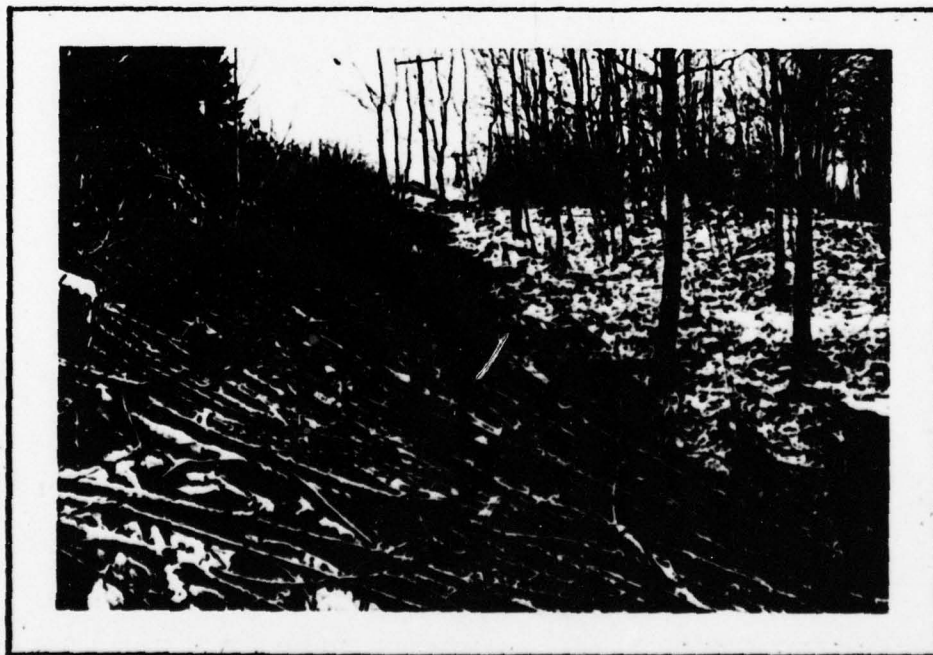
*DOWNSTREAM FACE OF THE DAM  
SHOWING CUT BRUSH LEFT IN PLACE*

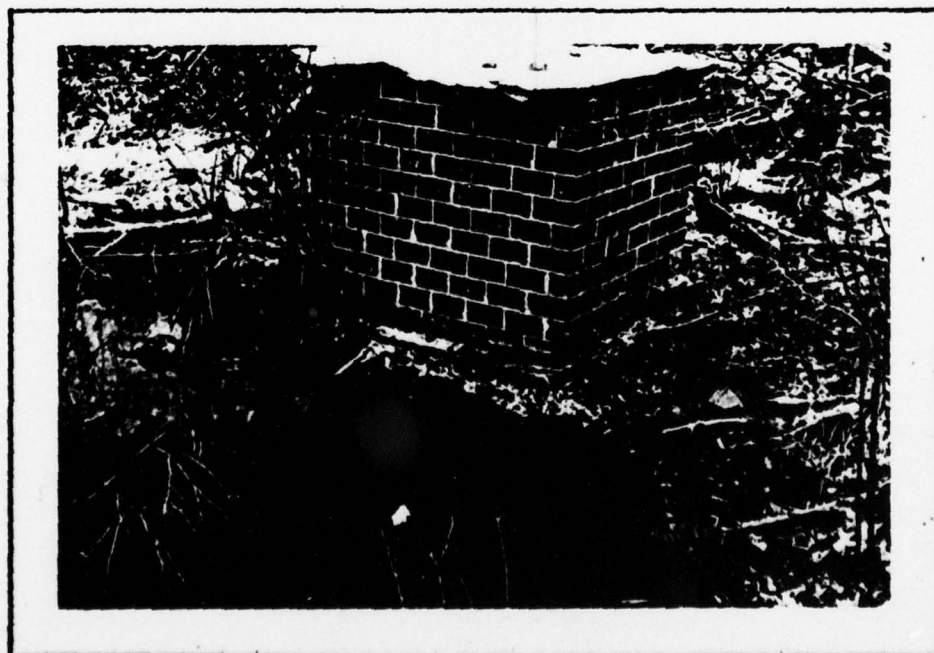
*THE GATE VALVE SHELTER. DISCHARGE IS FROM  
THE RESERVOIR DRAIN PIPE AND SEEPAGE*

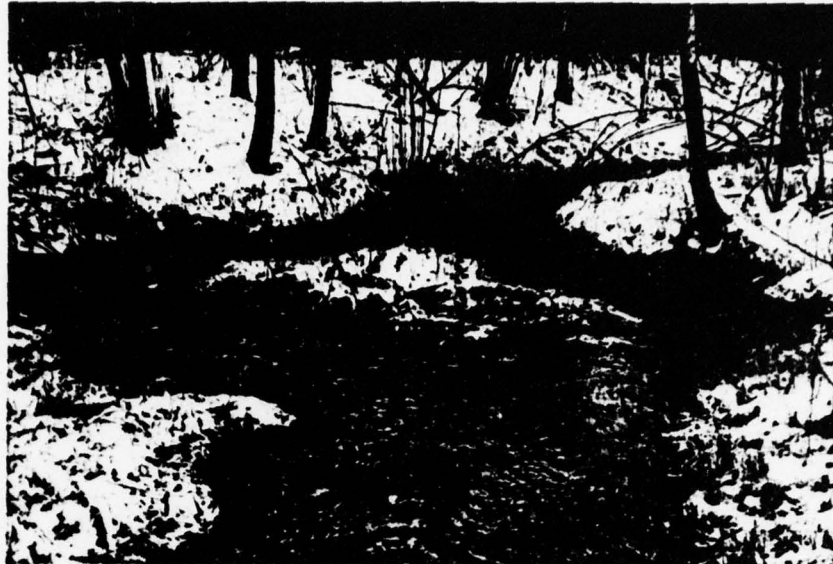
*APPROXIMATELY 10 C.F.S. DISCHARGE FROM  
RESERVOIR DRAIN PIPE AND SEEPAGE ABOUT  
50 FEET DOWNSTREAM FROM THE DAM*

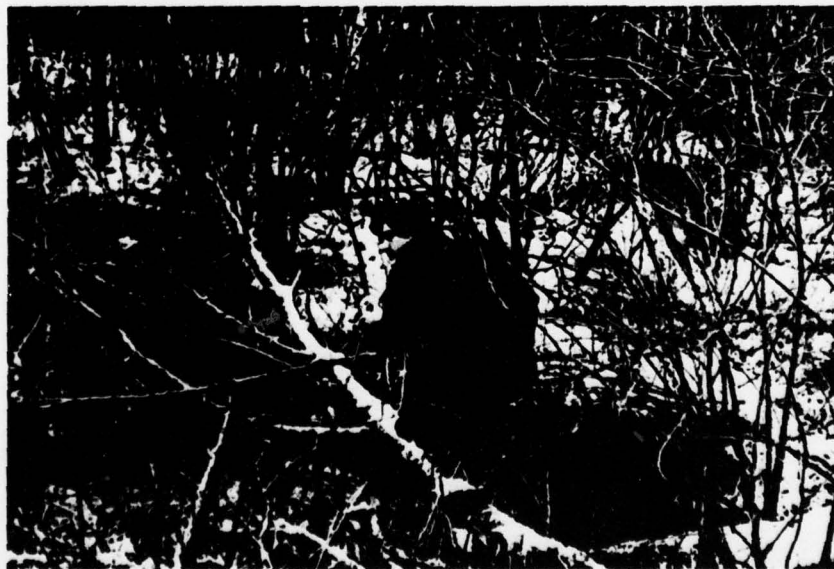
*DISCOLORED SEEPAGE FLOW IMMEDIATELY  
DOWNSTREAM OF THE DAM*

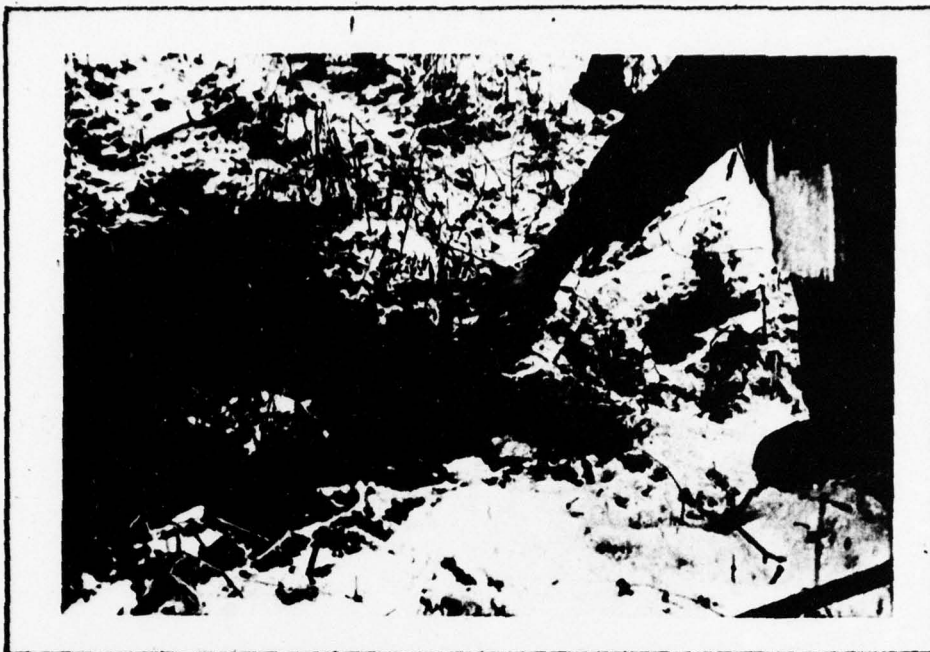
*CLOSE UP OF THE SEEPAGE FLOW  
IMMEDIATELY DOWNSTREAM OF THE DAM*

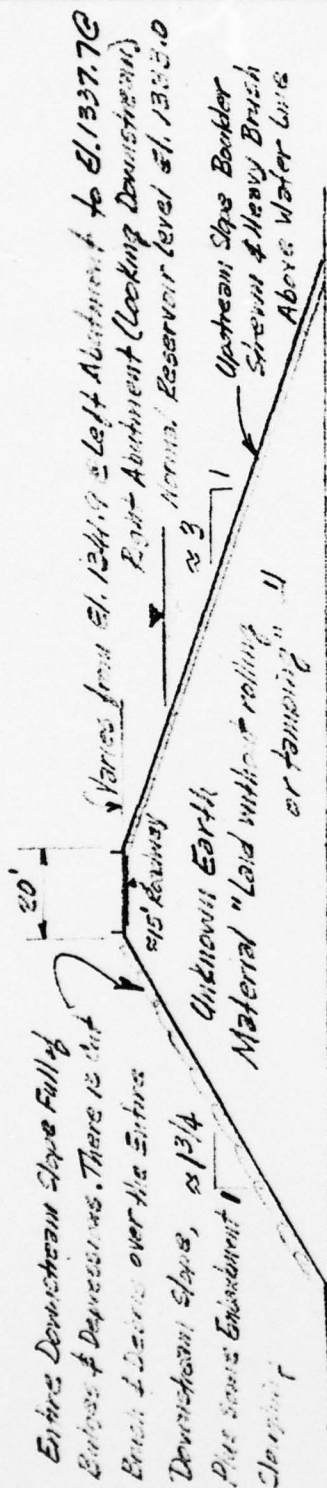
TYPICAL SECTION OF DAM

May Seep Along Max. Height of Embankment  $\approx 44'$   
dike toe
